CITY OF BALTIMORE SMOKE TESTING OBSERVATION SUMMARY JONES FALLS SEWERSHED

BALTIMORE CITY PROJECT 994 REI/DRAYCO

Unique Test ID: 333	Date: 06/12/2008	Basin: JF-19
Defect No: 01	Supervisor: E.R.	Dye Test Recommended: N
House No: 734	Street Name: E. 20TH	Street Type: ST.
Source Type: 16	Location: 14	Severity: 03
Sector: 01	Drainage Area: 1

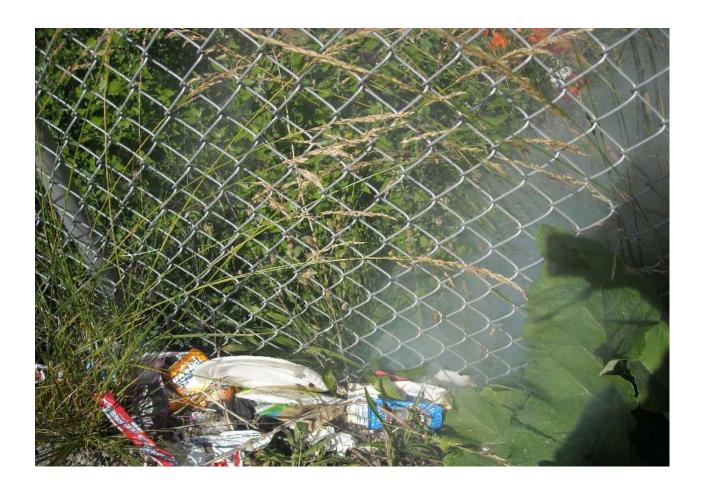
Photograph No: OB01-01 Filename: 0994-333_OB01-01.jpg

Comments: SMOKE EMINATING NEAR FENCE, UNKNOWN SOURCE TYPE

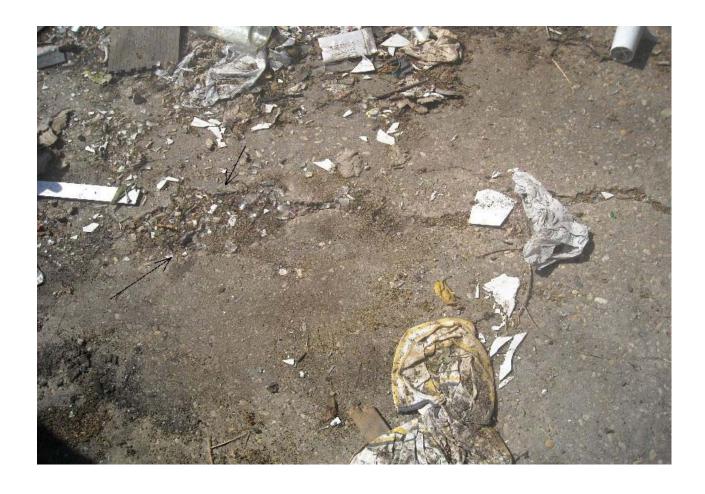
Photograph No: OB02-01 Filename: 0994-333_OB02-01.jpg

Defect No: 02 Supervisor: E.R. Dye Test Recommended: N

Source Type: 01 Location: 12 Severity: 02

Comments: SMOKE EMINATING FROM CRACKS, 10 FT UPSTREAM OF S37MM_038MH
